bowman
TRAILER LEASING

Inbound Inspection

Customer: DOUBLE R TRANSPORT

UNIT: 601341

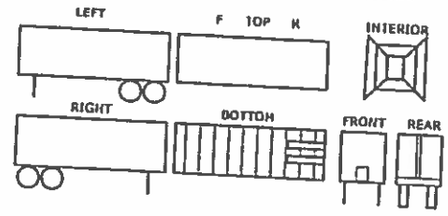
All new damage and deficiencies versus outbound inspection noted below

TECH	BILLABLE	REPAIRS TO BE PERFORMED	LABOR HOURS	MATERIALS COSTS
		LEFT RADIUS DAMAGE		
		BENT ICC		
		MUD FLAP BRACKET BENT		
		RIGHT DOOR SEAL DAMAGE		
		DAMAGED SCUFFLINER
